Case 319 : Narrative

Case Vehicle (A): 1999 Mercury
Type: Tracer LS, 4-door sedan
Driver: 40-year-old male
CDC: 12-FCEN-2

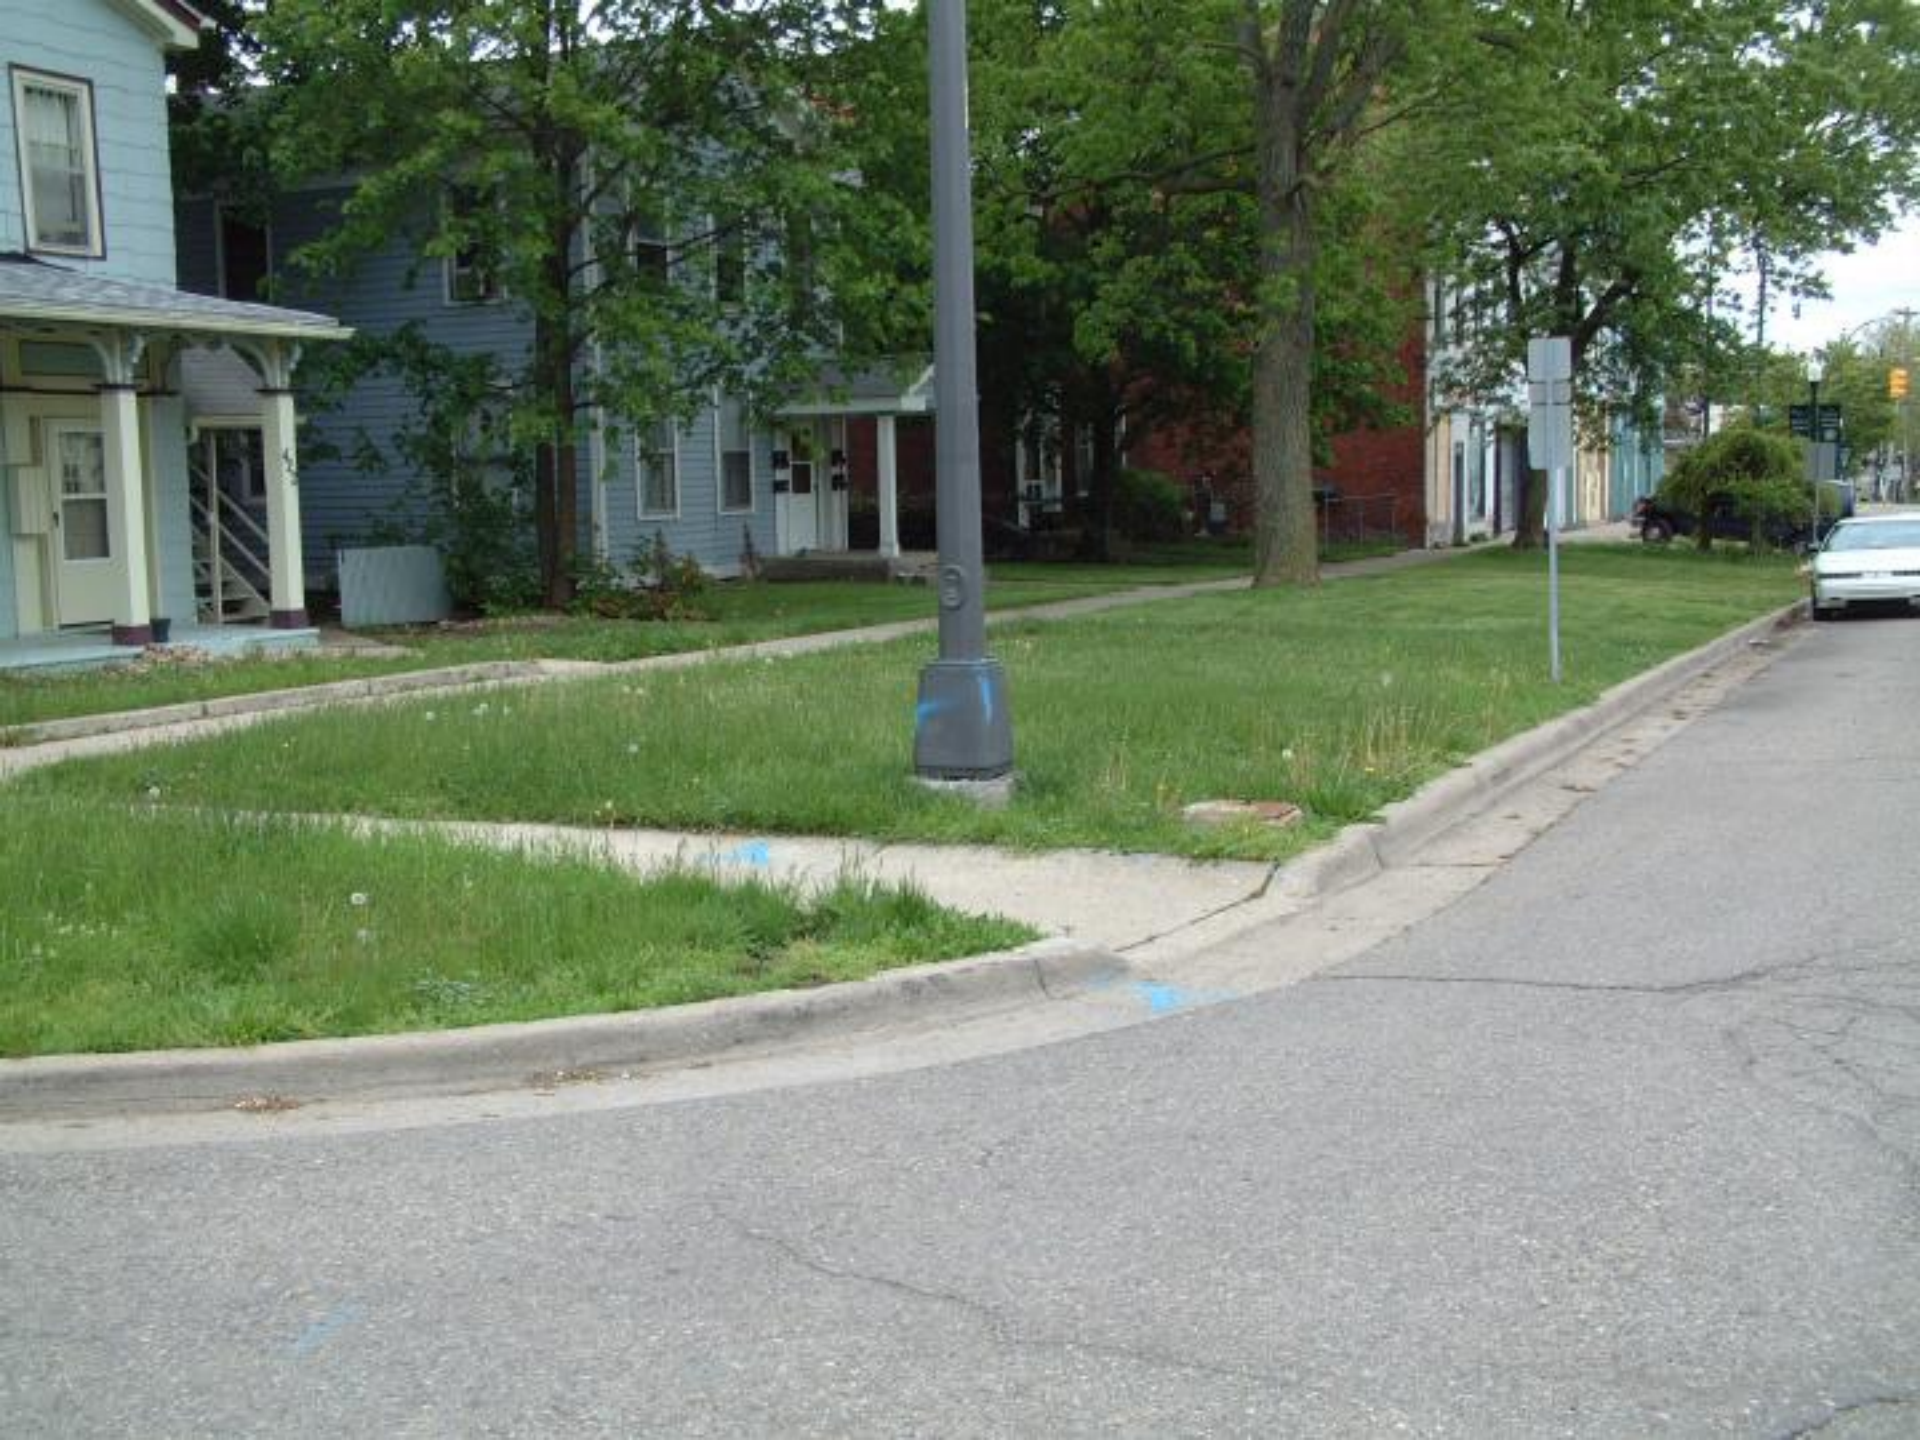
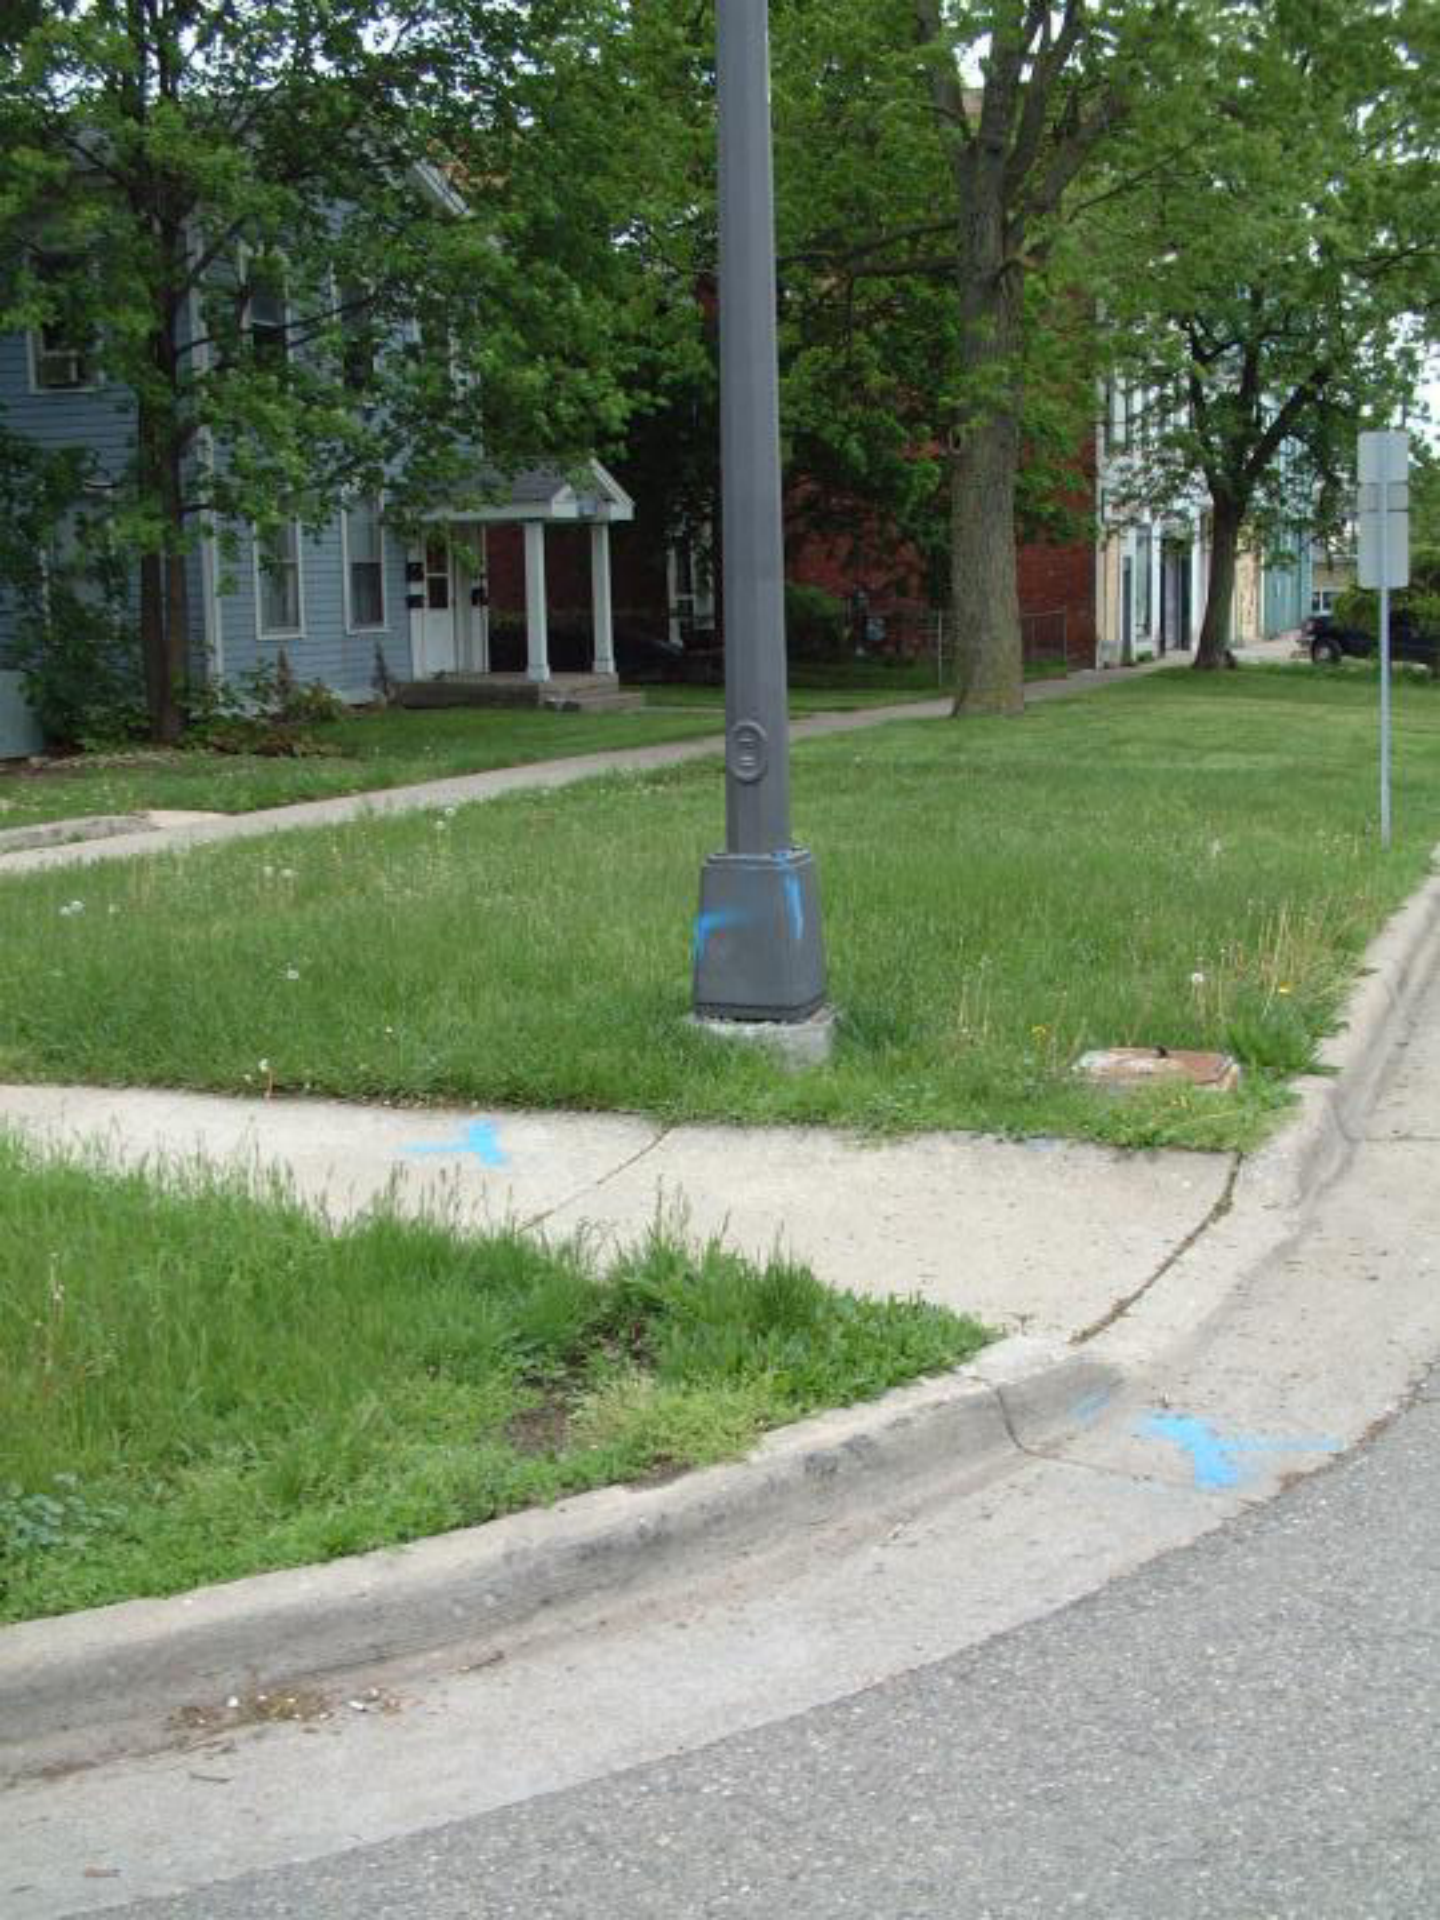
[18](#) [19](#) The center portion of the front bumper was damaged and the bumper cover was completely separated from the vehicle. The grille was damaged and both headlight assemblies were broken. There was direct damage to the center of the hood and it was pushed up and to the rear. [20](#) There was no damage to the hood latch or hood hinges, although the rear edge of the hood was slightly elevated. [21](#) [22](#) There were two cracks in the right side of the windshield from contact by the right-front passenger airbag cover, and two cracks in the left side of the windshield from contact by the driver.
